Enhanced Preliminary Assessment Report:

Tappan Army Housing Units
Tappan, New York

November 1989

Environmental Research Division
Argonne National Laboratory
Argonne, Illinois 60439

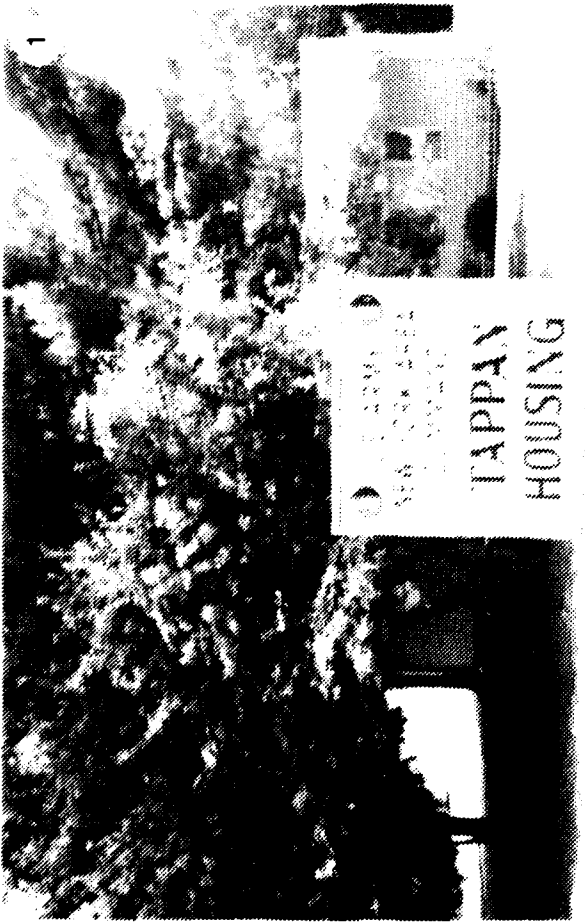
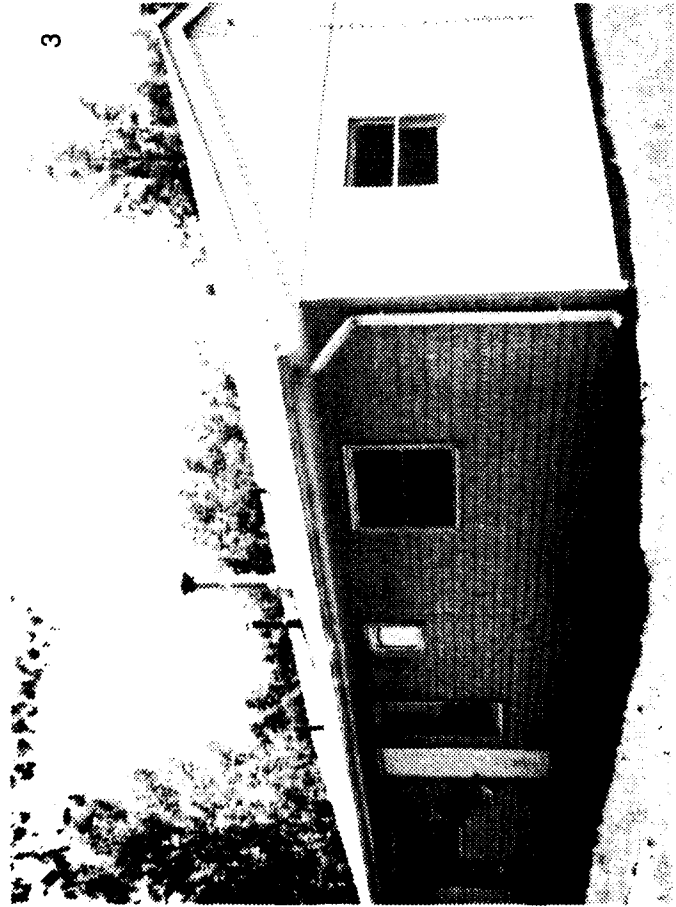
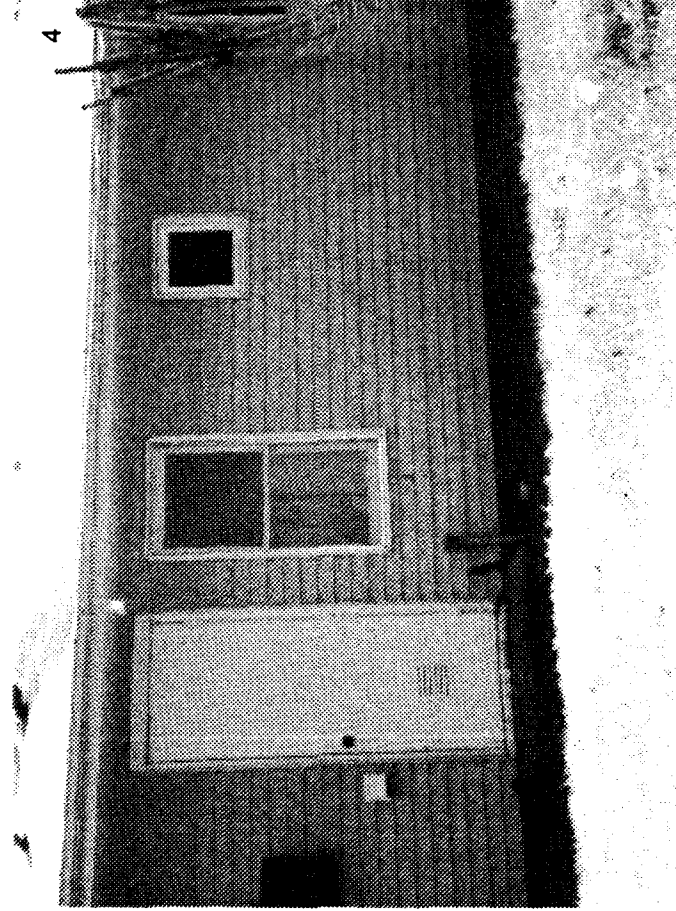
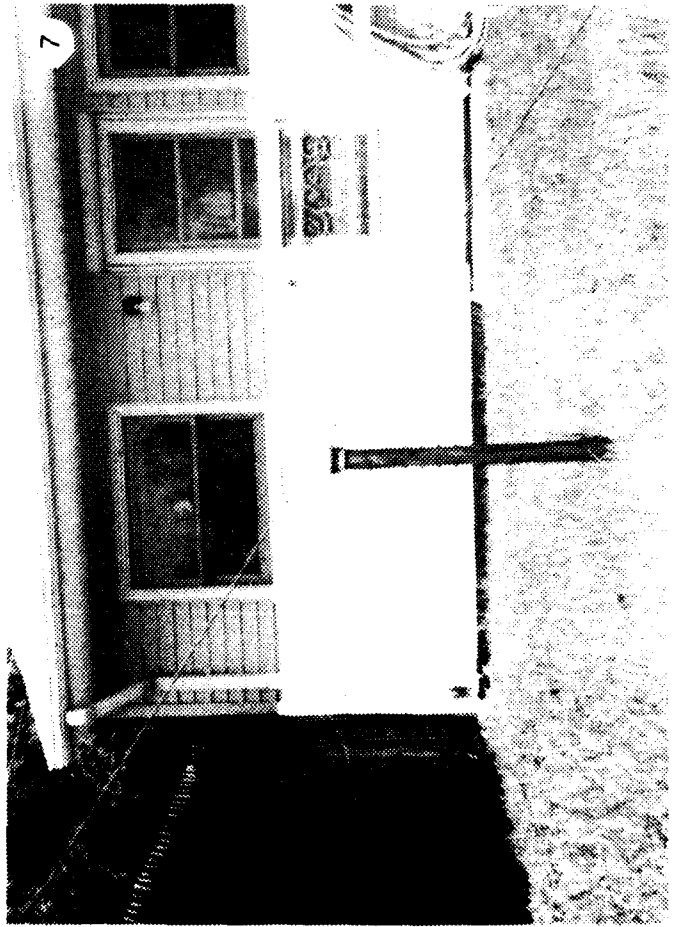
1. Sign at entrance to Tappan housing area.
2. View looking south along Lafayette Street at unit #415.
3. Rear of unit #415.
4. Rear of unit #415; note underground storage tank vent pipe and fill port in foreground; underground storage tank made of fiberglass.
5. Furnace and water heater typical of Tappan housing units.
6. Living room of vacant unit #415; note floor heating ducts.
7. Underground storage tank vent pipe at unit #417; one of six units at Tappan with a steel underground storage tank.
